SUBJECT John Anglin, Clarence Anglin and
Frank Lee Morris Escape from Alcatraz

FILE NUMBER 76-26295

VOLUME NUMBER Enclosures 76, 137, 155 and 179

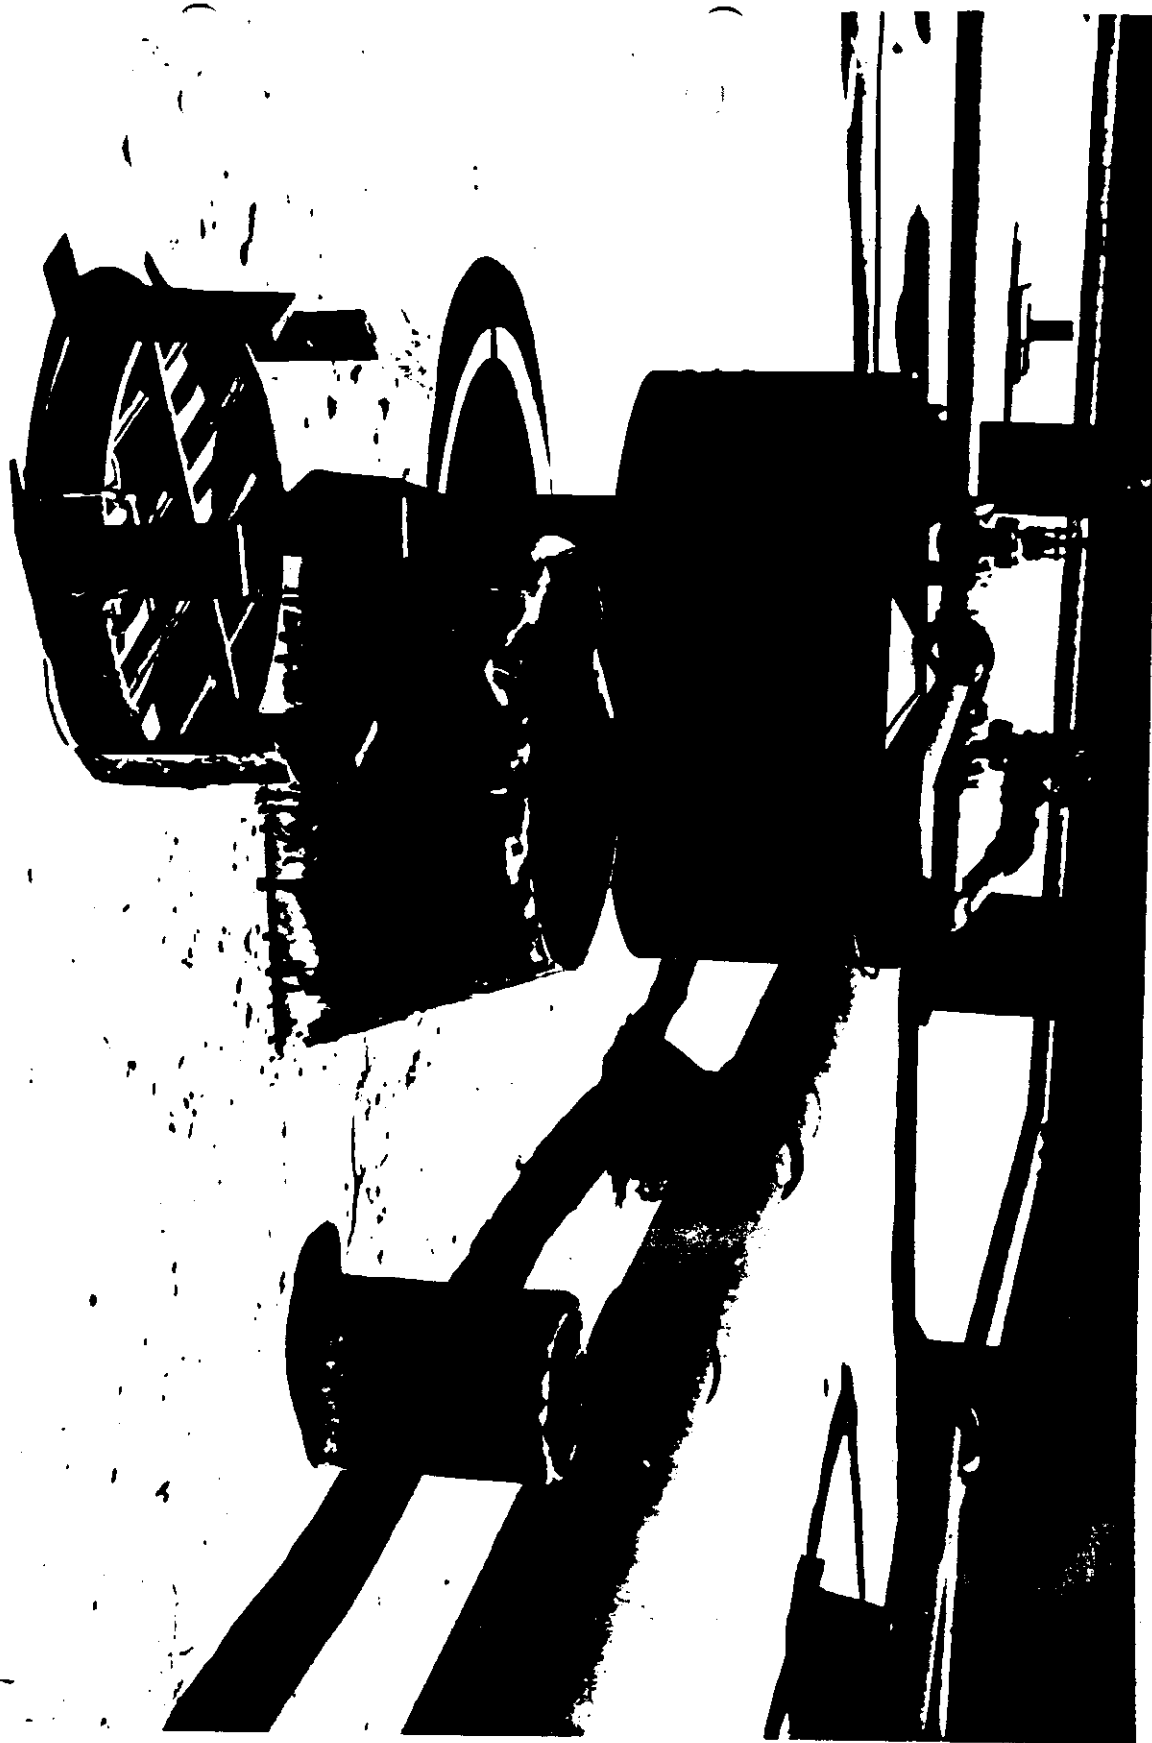
- 1-1 Photograph of ventilator on roof over Cell Block B. Photo taken looking south and shows in immediate foreground heavy iron grate which normally fits inside of funnel-shaped galvanized metal cone appearing immediately above grate. The object to the rear behind the opening is the ventilator top which was removed to permit the Subjects to escape.

The stub pipe appearing at center right is the vent stack for the lavatory facilities.

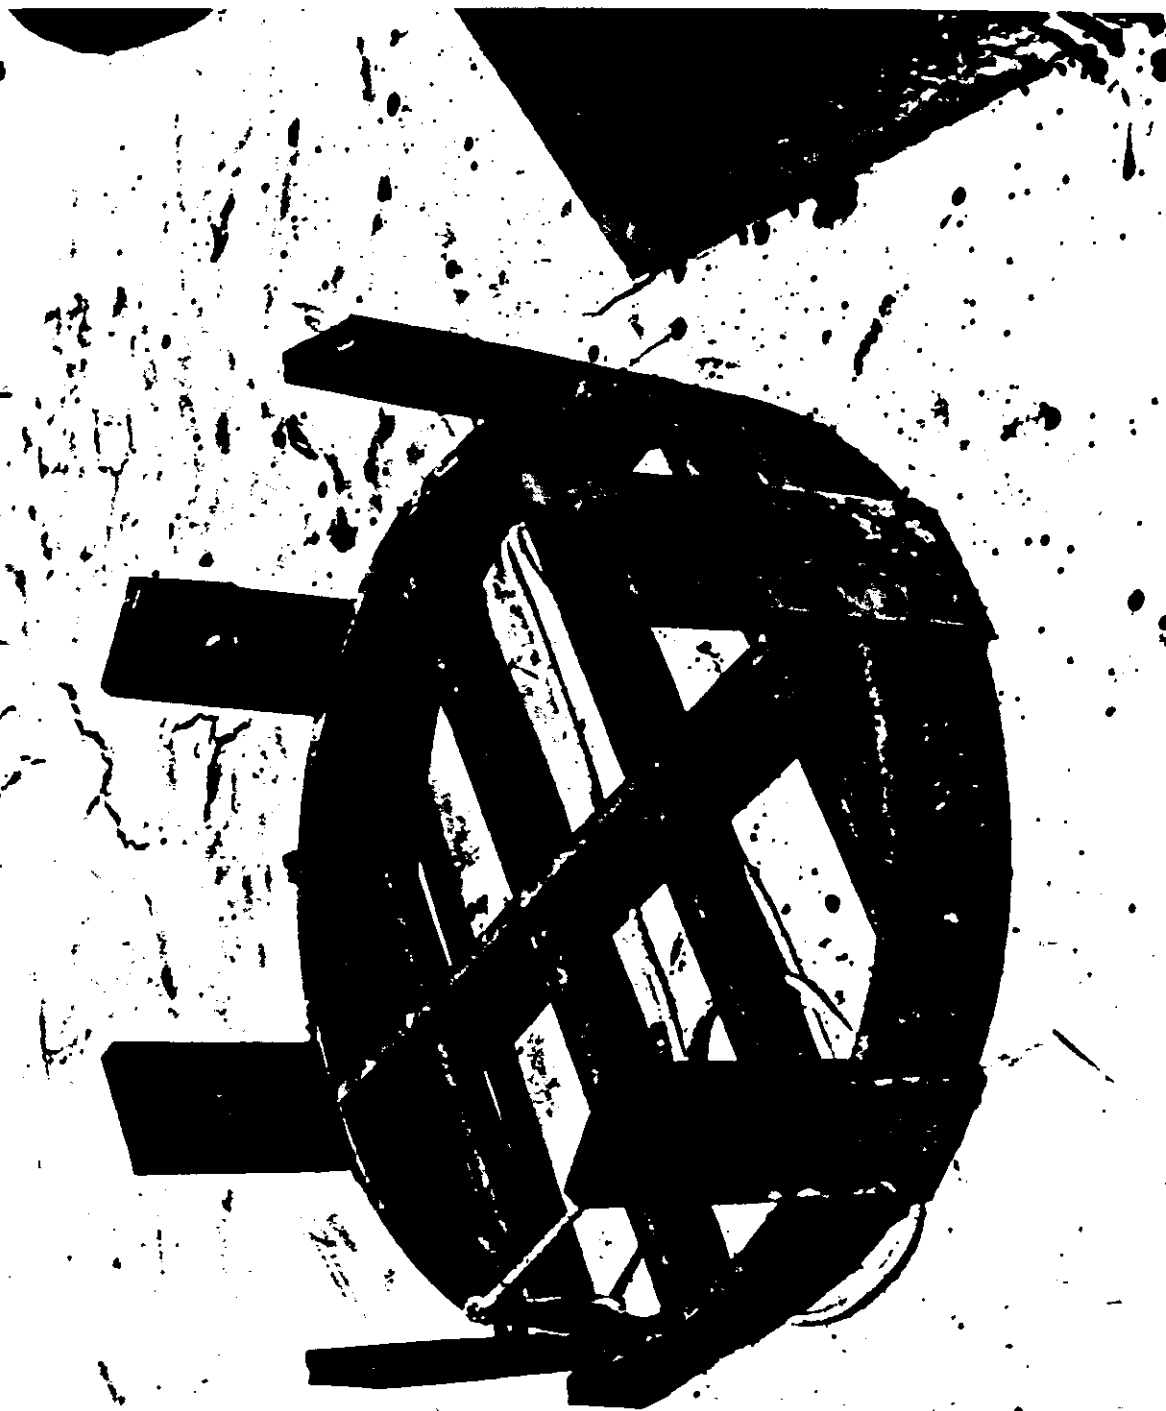
1-2 This is a more detailed photograph of the galvanized metal grate shown in 1-1.

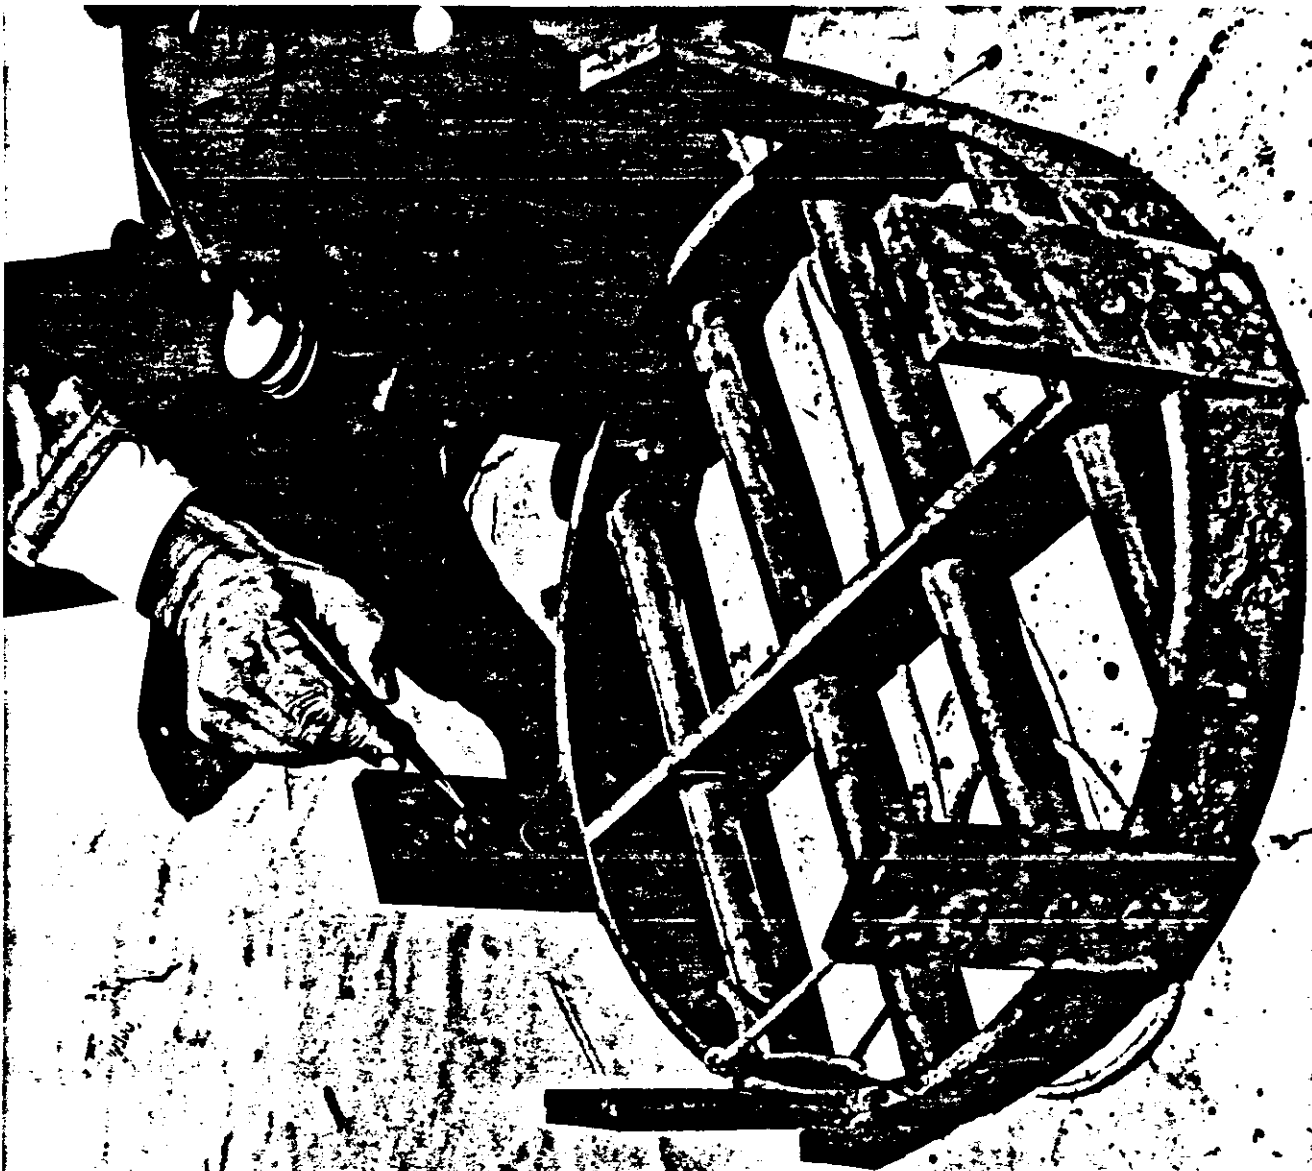
1-3 Same as 1-2 with the exception that pencil is used to point out the bolt head made of soap which is one of two found on the roof.

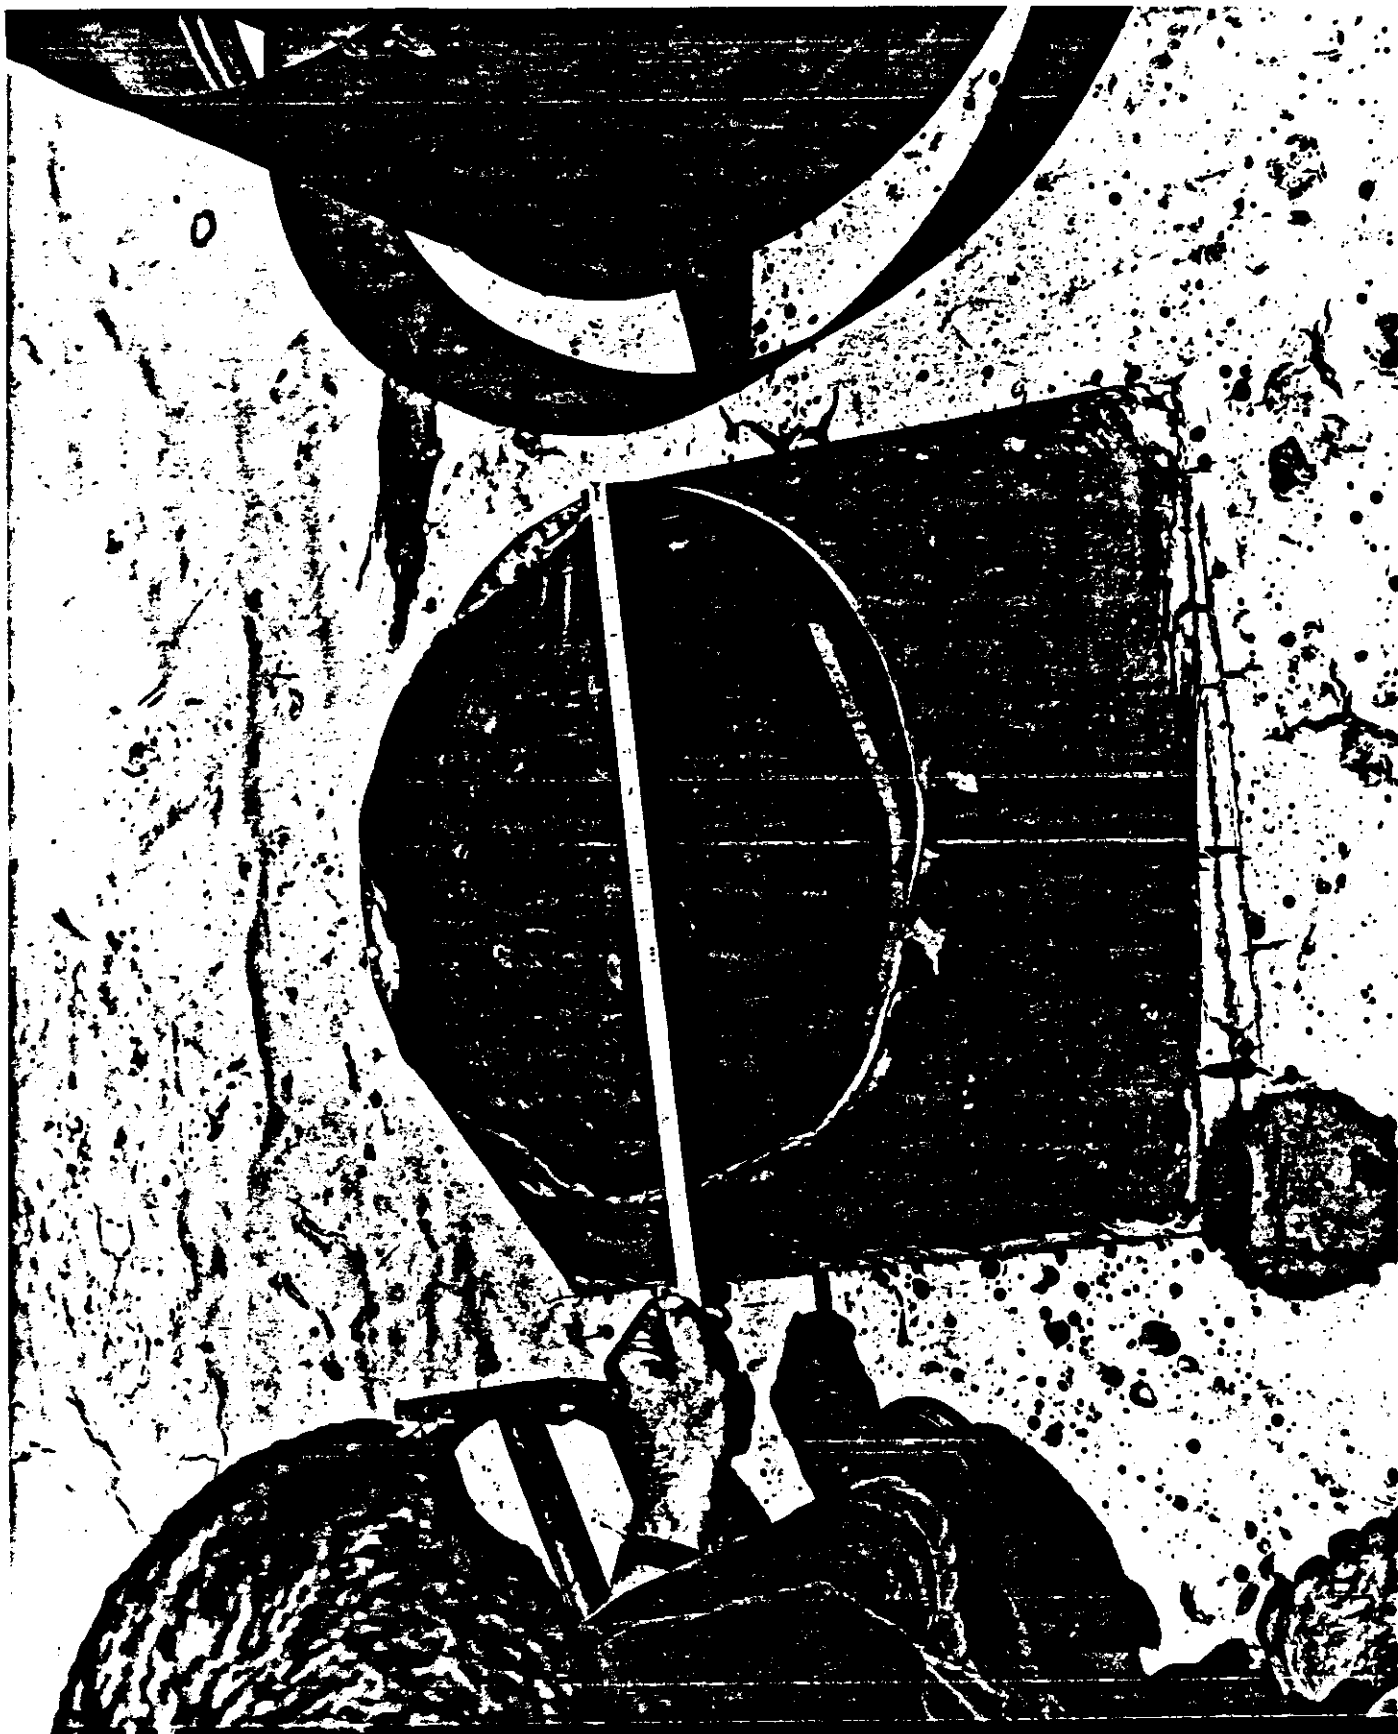
1-5 Photo same as 1-4 with the exception a tape is stretched across the opening showing the opening to be approximately eighteen inches in diameter.

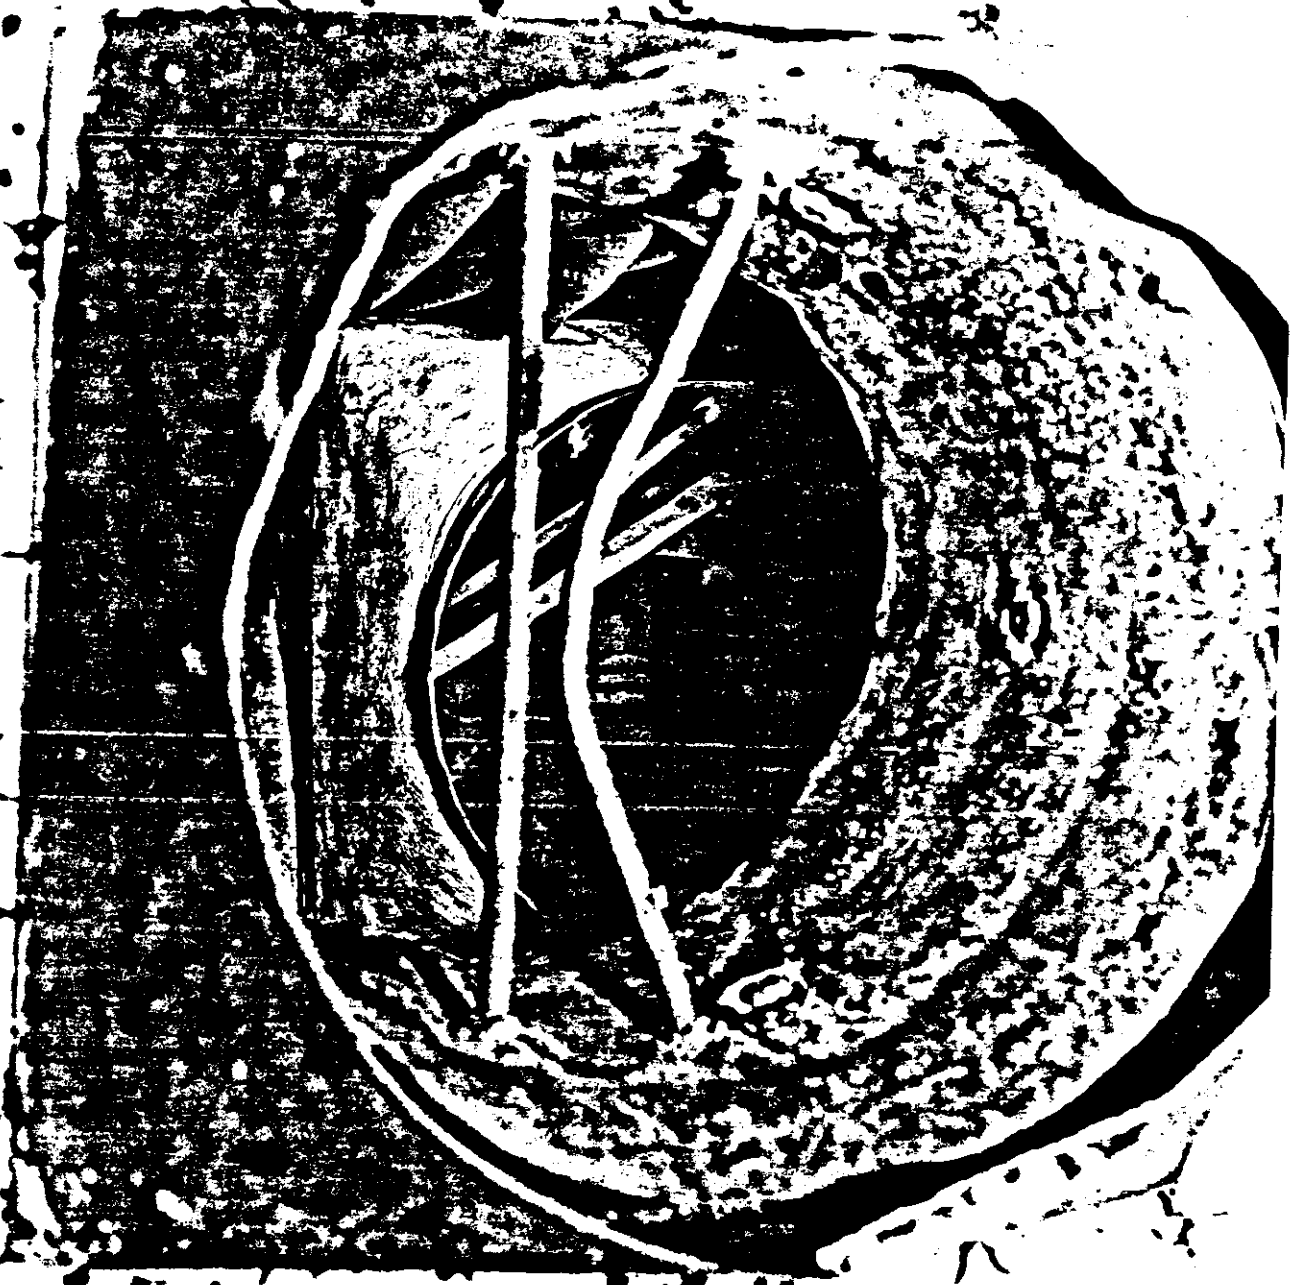
1-8 This photograph was taken directly over the ventilator opening on the roof and shows the vent re-enforcing rod and the stud holes normally used to fasten down the heavy galvanized grate shown in photographs 1-1, 2, and 3. Immediately below the opening may be seen the top of the motor housing which is normally offset from the roof opening and when in operation is joined by a galvanized gooseneck connection. The blades of the "squirrel cage" type air impeller may be seen just above the bent portion of the re-enforcing rod. The bent rod is on the eastern side of the hole.

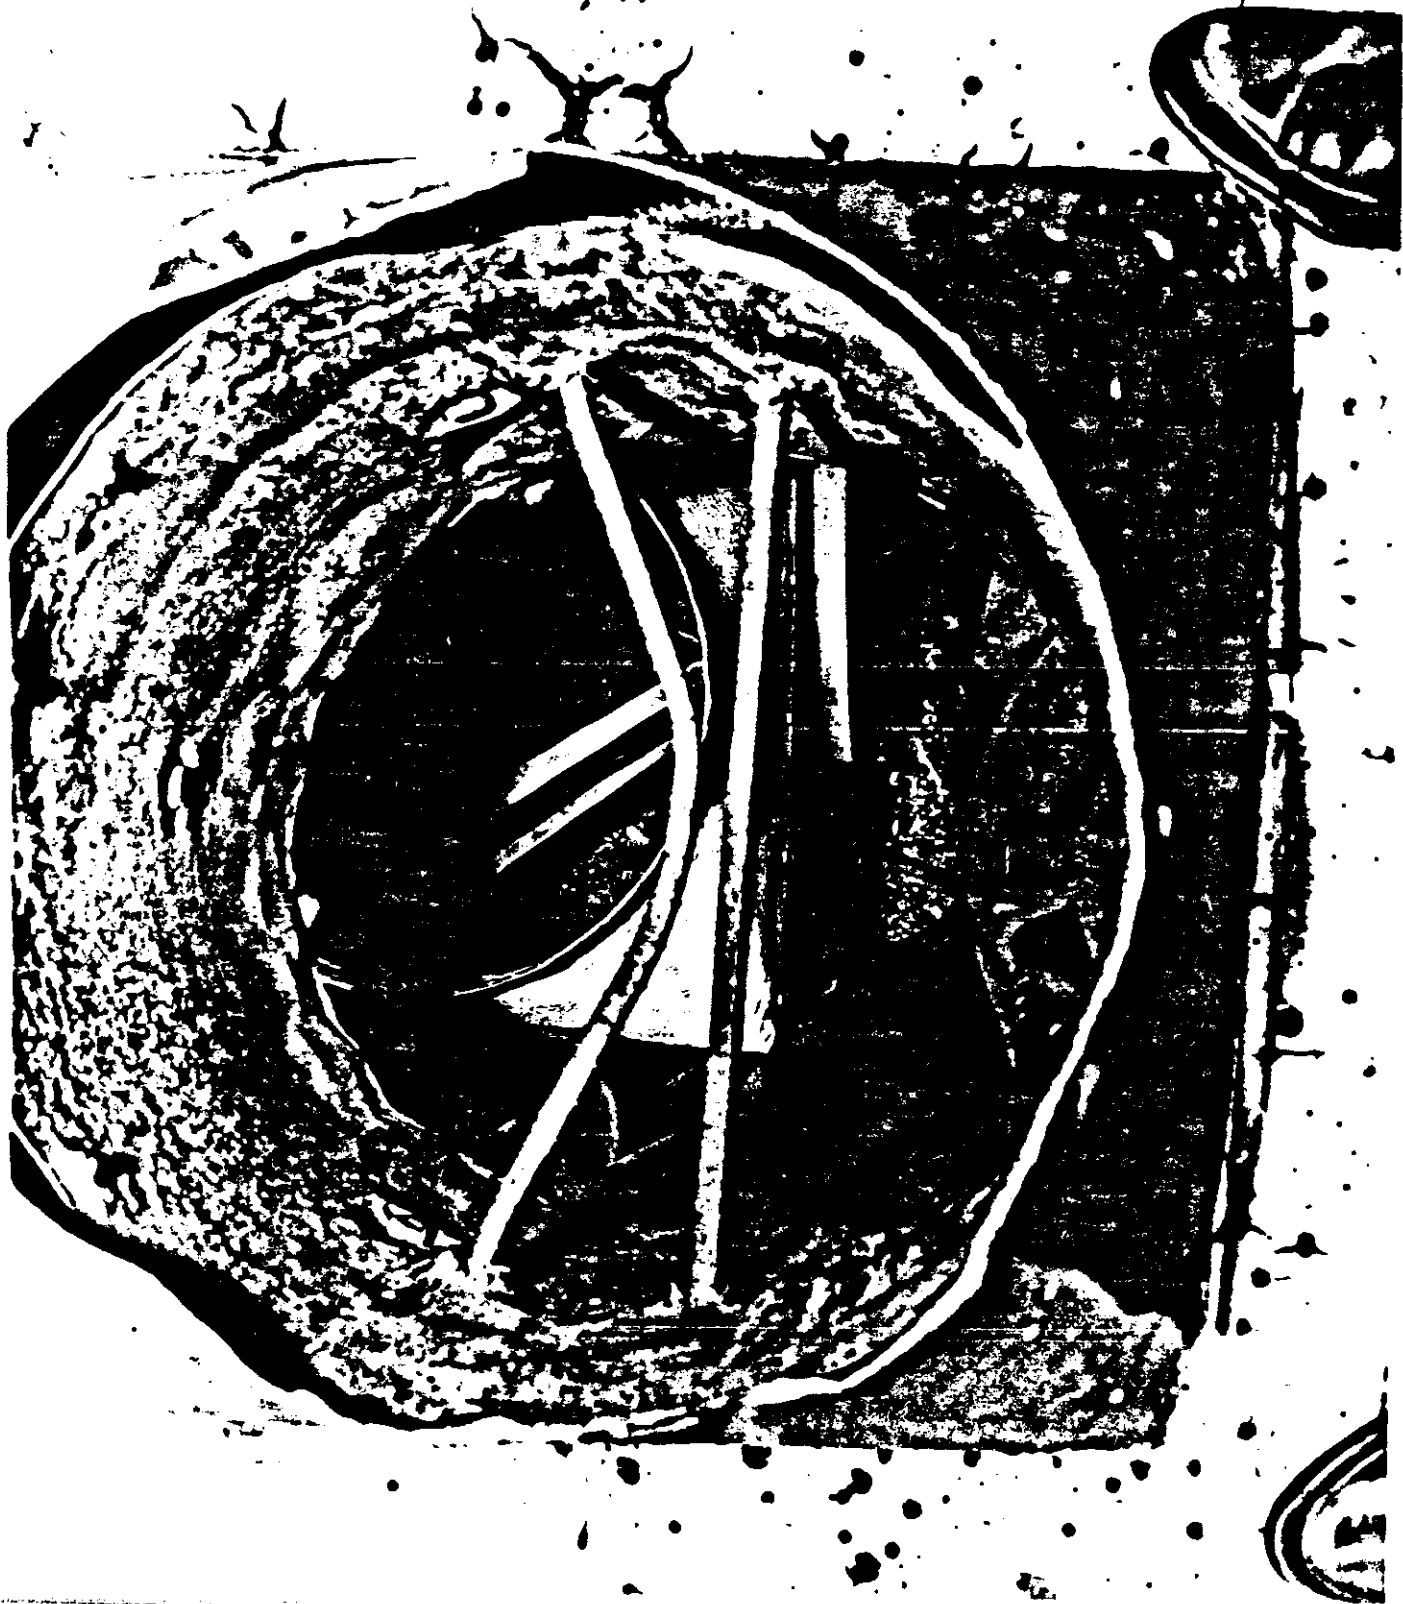
1-9 Same as 1-8 with the exception that more detail is shown concerning the blankets which were used to shield light from entering this opening.

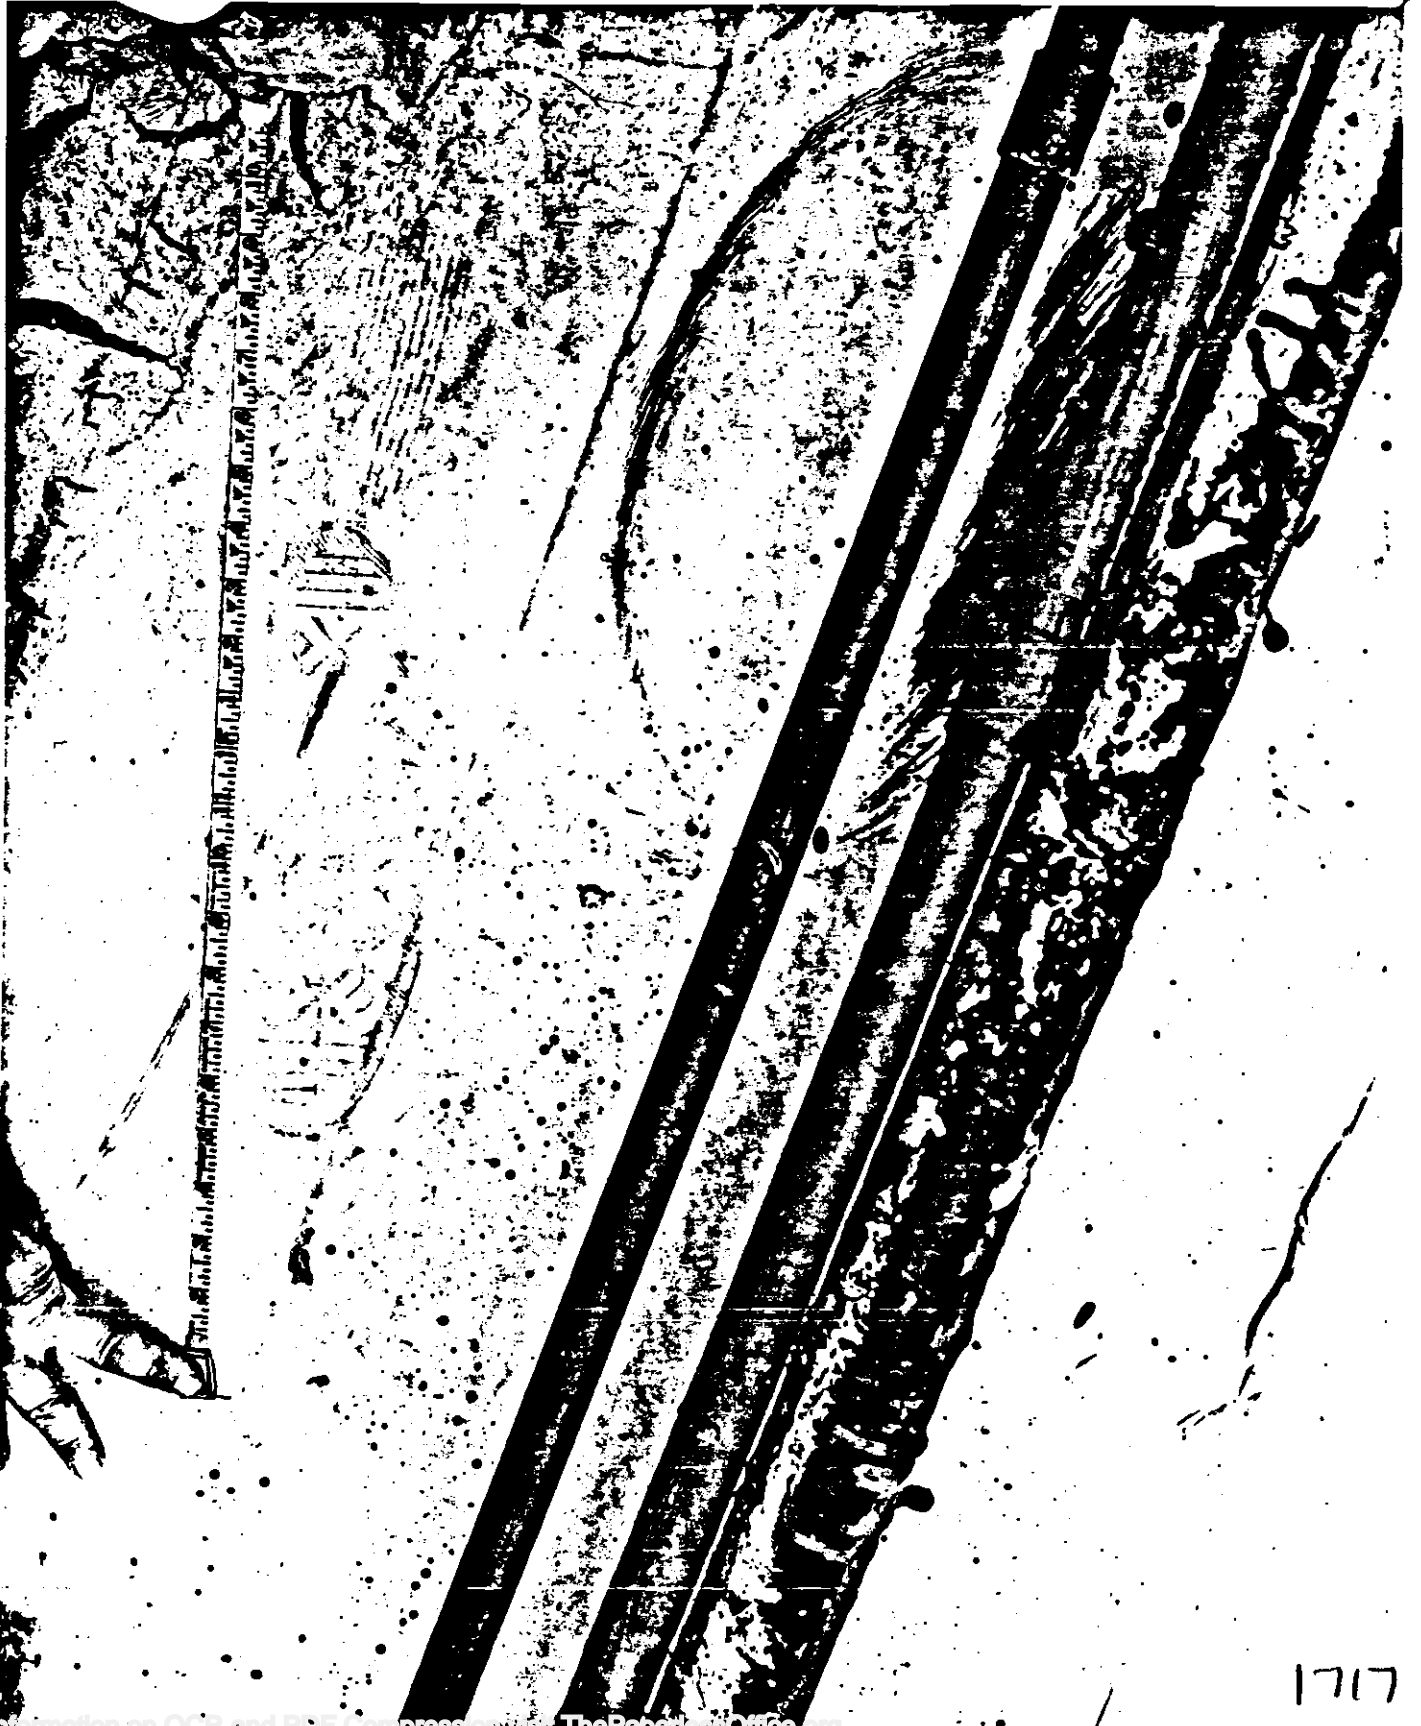
1-10 This is a photograph of an imprint of what appears to be the left foot. This print is headed in a northwesterly direction. The imprint appears to be that of the sole of a tennis shoe and is one of a number of fragmentary such prints visible on the roof indicating the direction of travel.

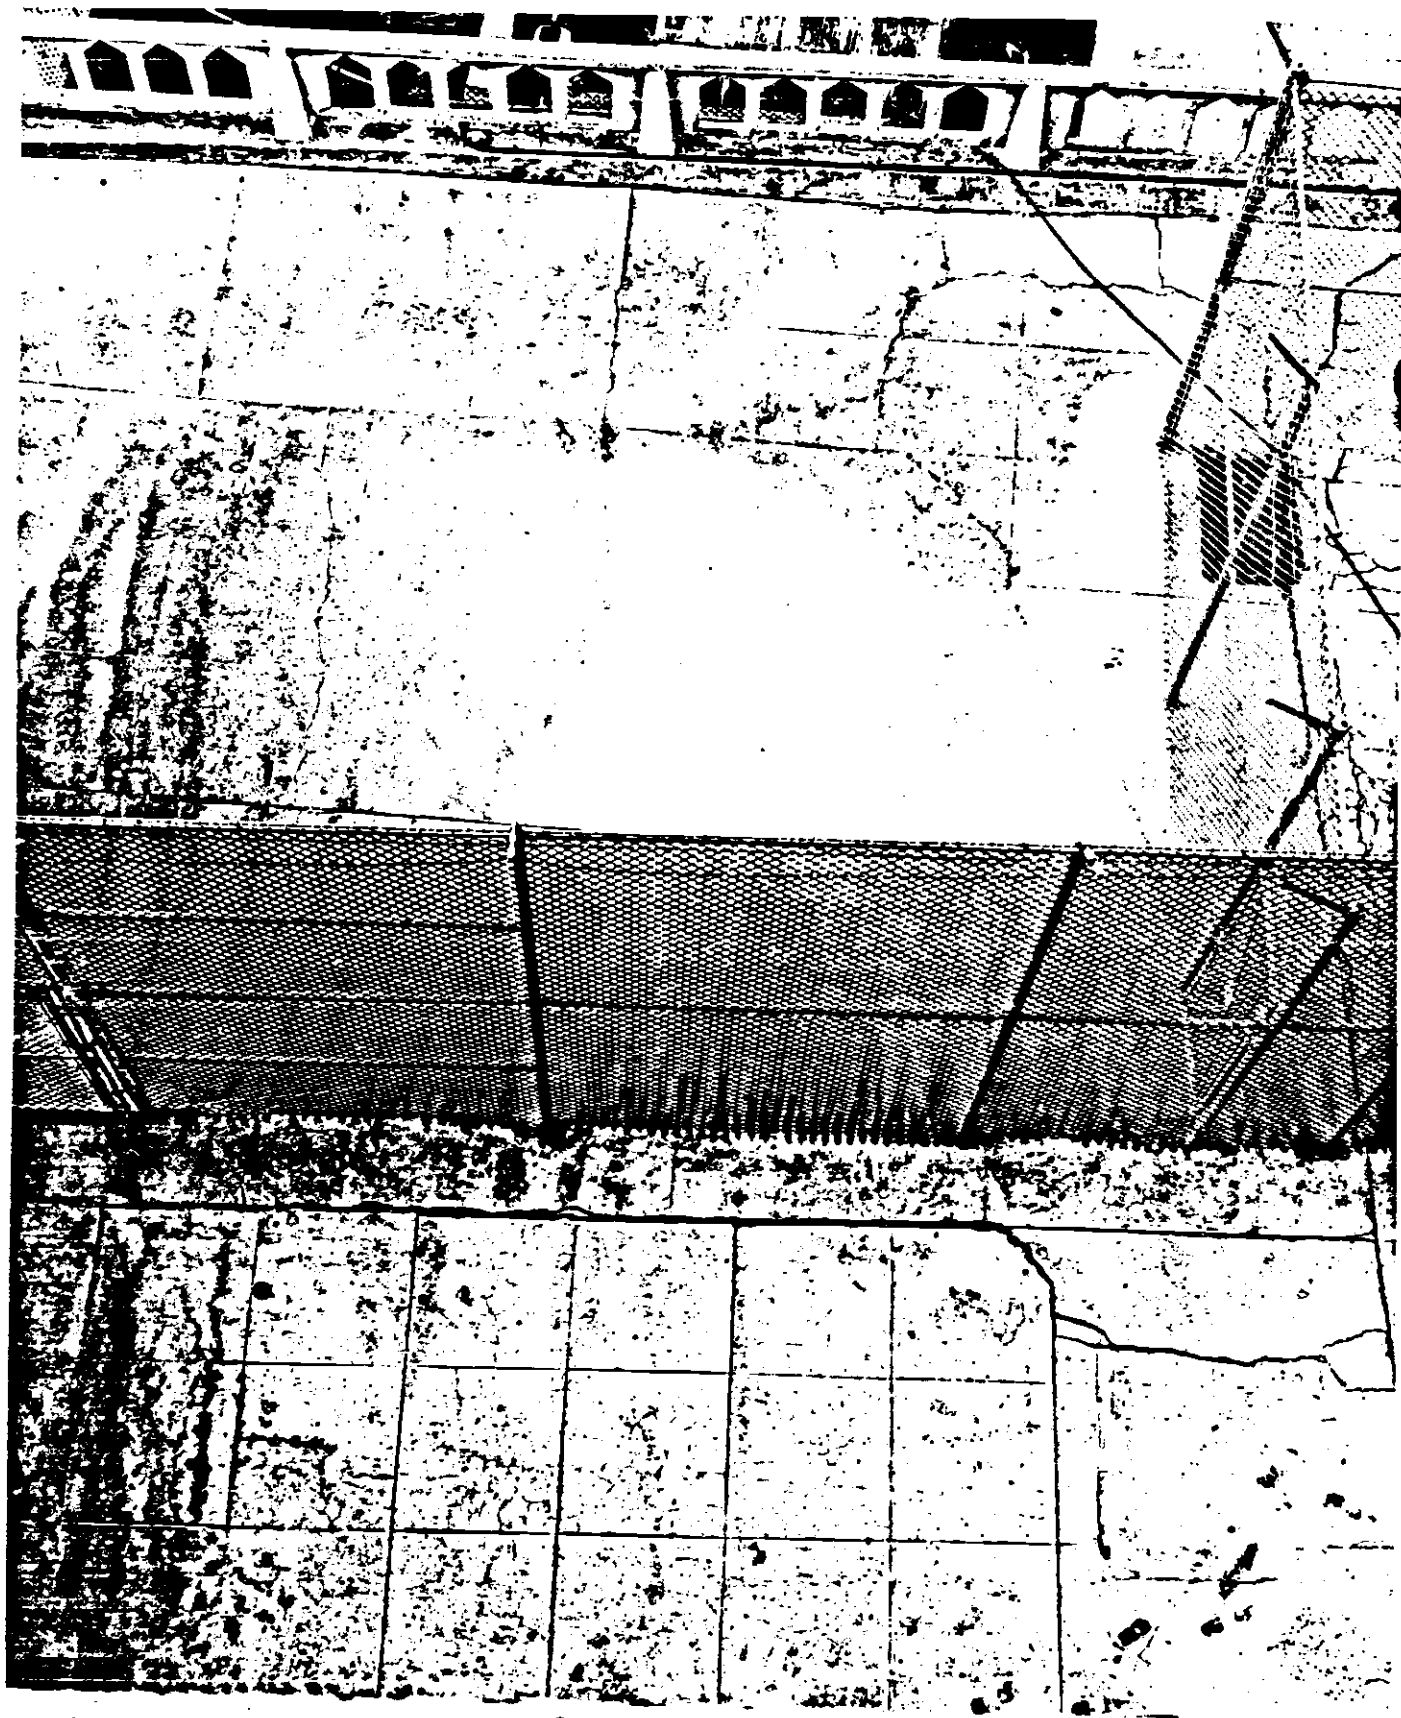
1-12 This photograph was taken from the north end of the building looking down to the enclosed ground area which is believed to be the area the Subjects descended to. The distance from the top ledge of the building to the concrete shown in the lower foreground is approximately forty-five feet.

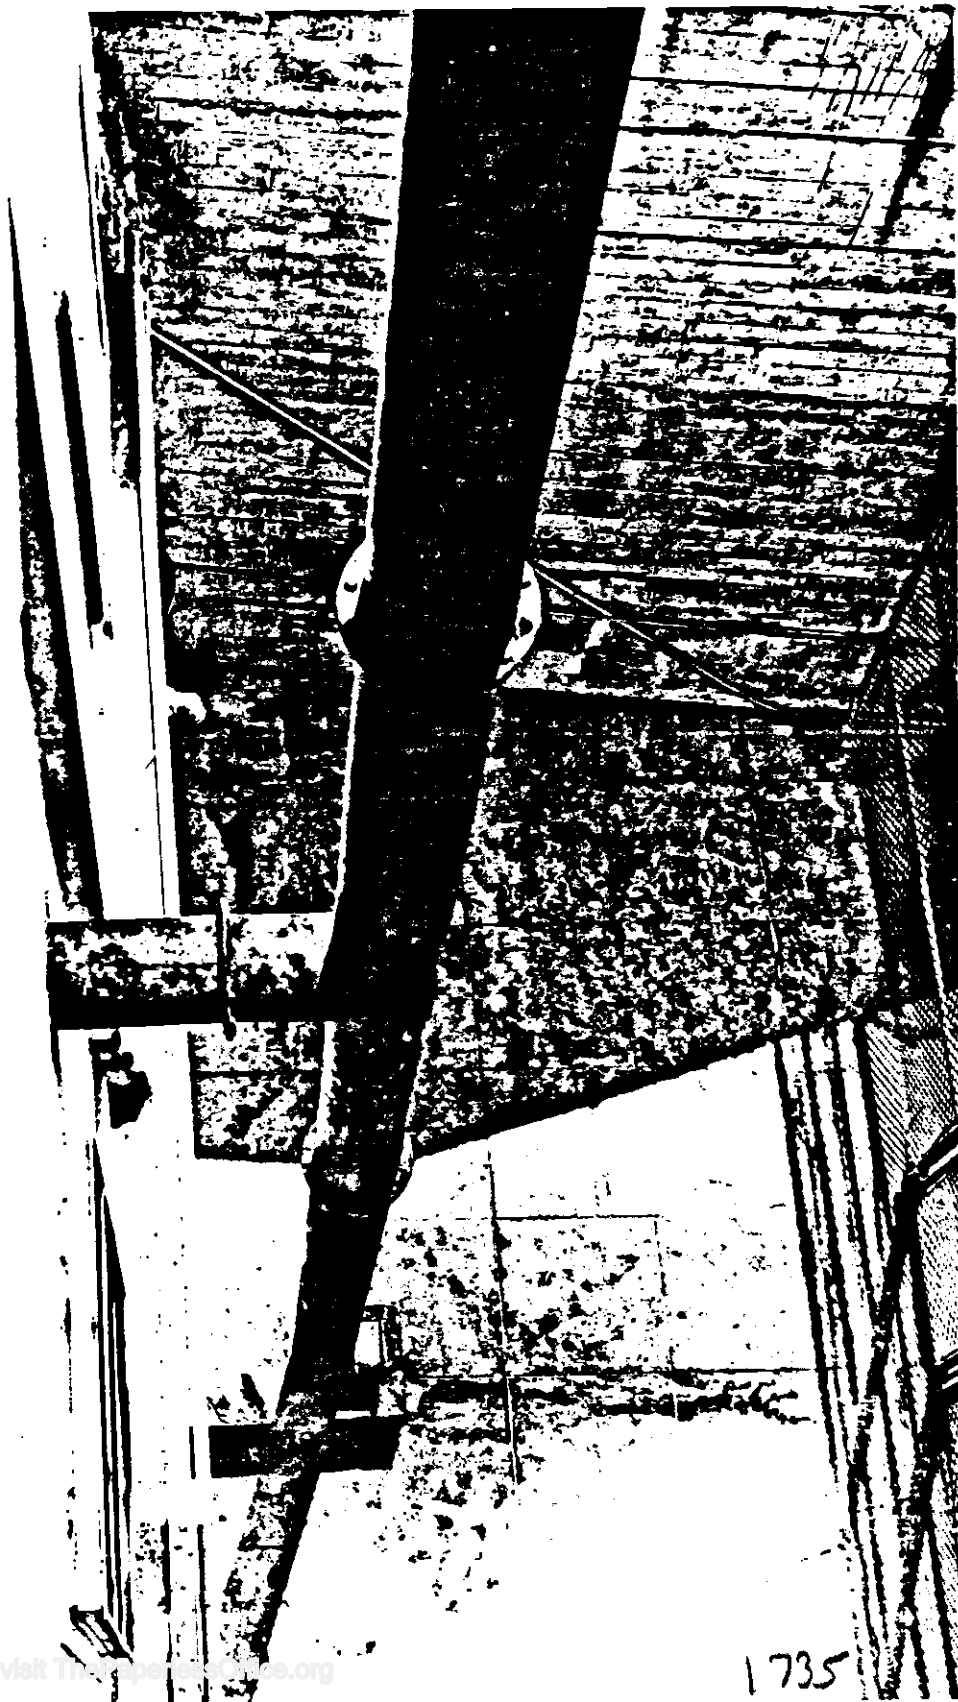
2-7 Photograph taken by leaning over the edge of the building showing the bake oven stack extending from above the roof line to the clean out on the concrete slab at ground level. The edge of the building is at left center and the distance from this to ground level is approximately forty-five feet. The wire screen topped with barbed wire seen at lower right is approximately twelve feet high.

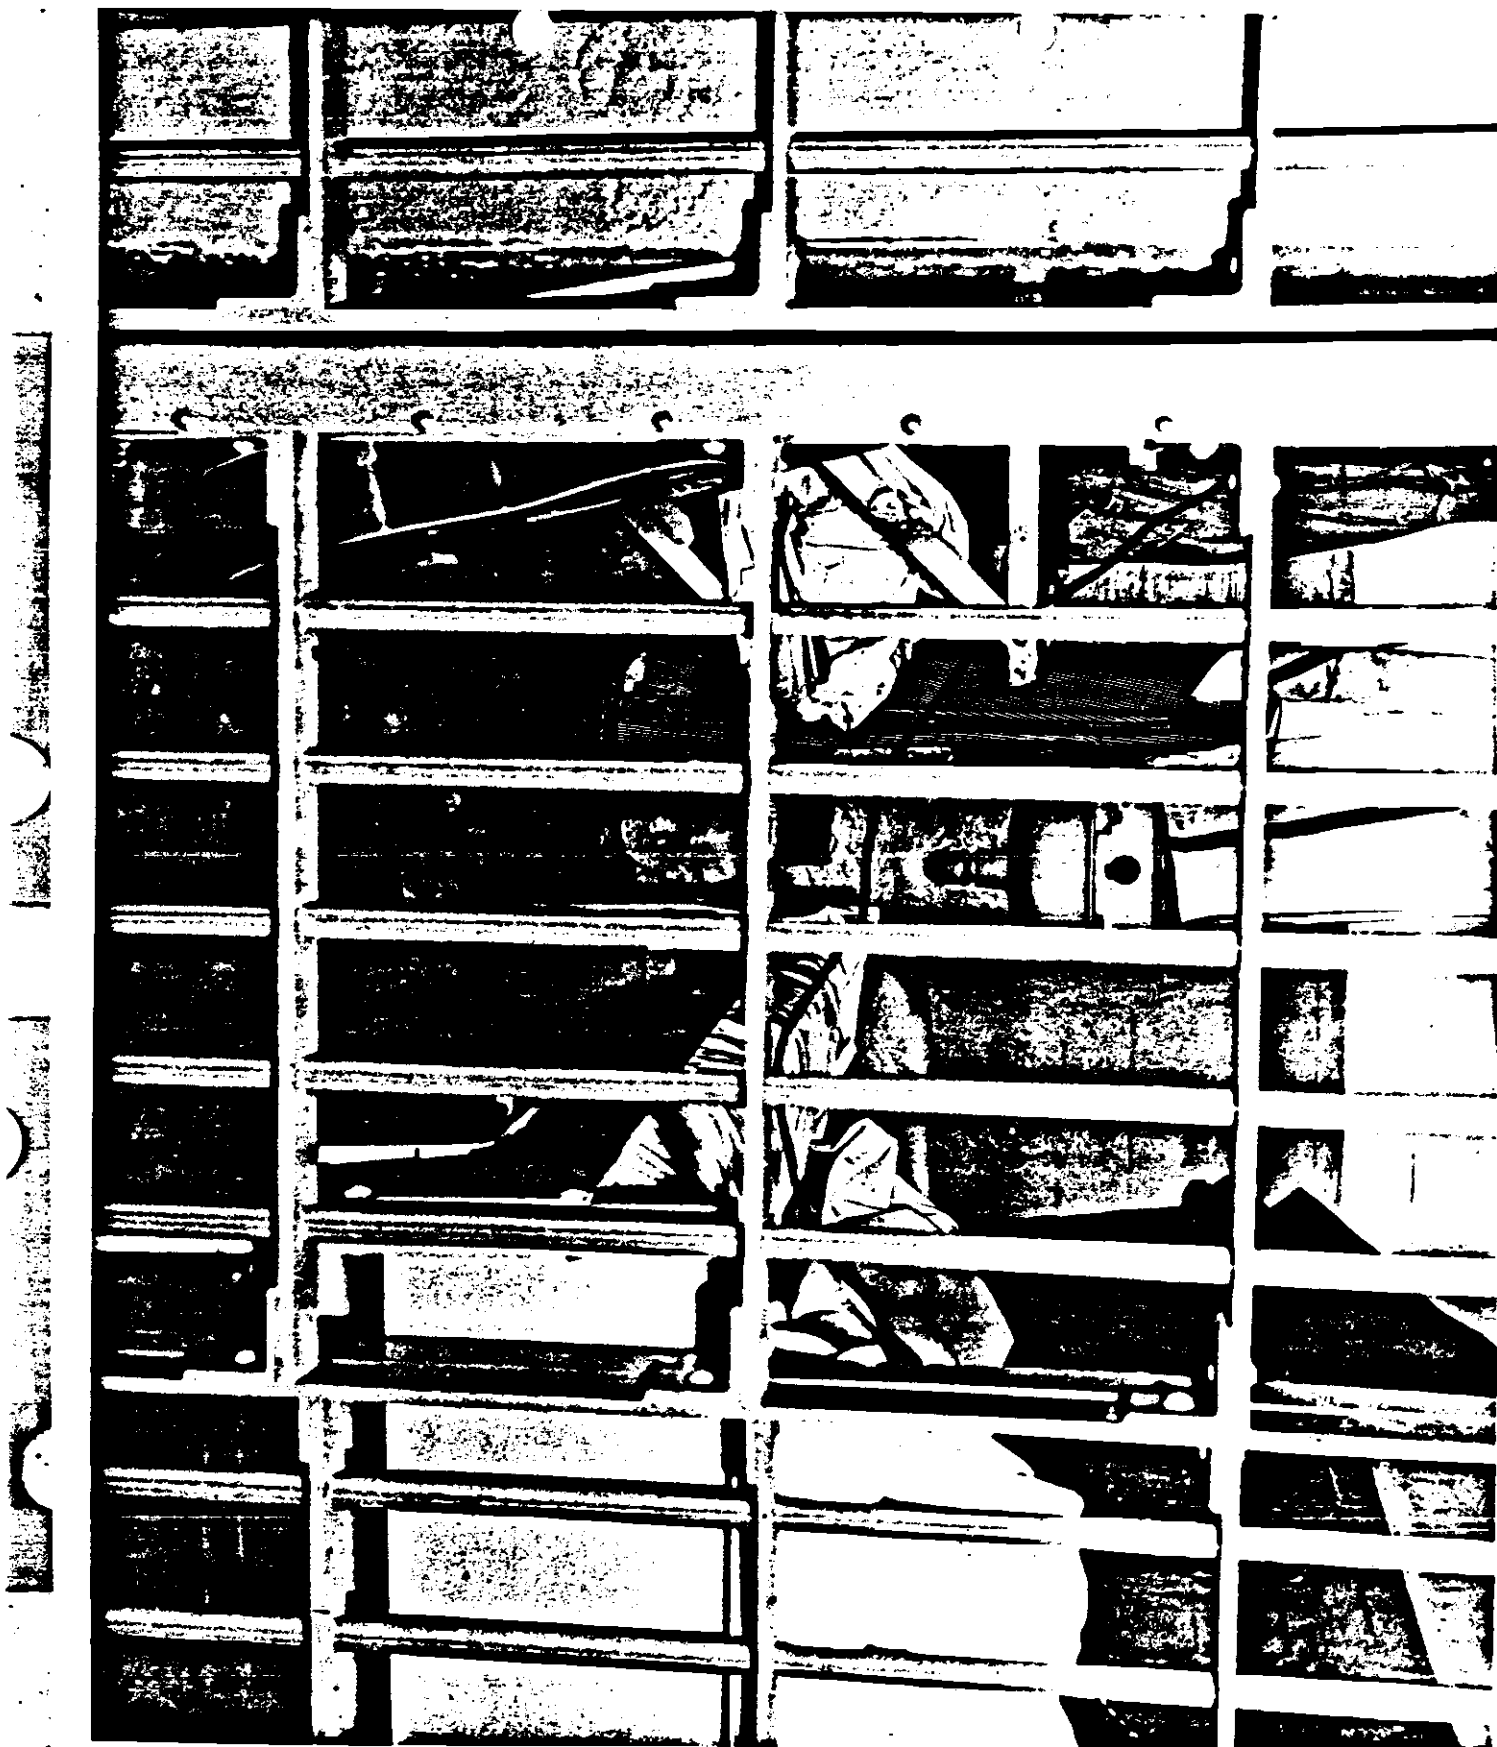
~~3-2~~
3-2

3-2 Photograph of the same cell taken head-on showing the opening at the rear of the cell under the wash basin which permitted Subject CLARENCE ANGLIN to escape. In this photograph the hole is partially covered by a piece of cardboard, the source of which and use of which is unknown.
